TYNDALL AFB BOMB DAMAGE REPAIR FIELD TEST, DOCUMENTATION AND ANALYSIS

Lawrence D. Hokanson, Capt, USAF
Air Force Weapons Laboratory

October 1975

Final Report

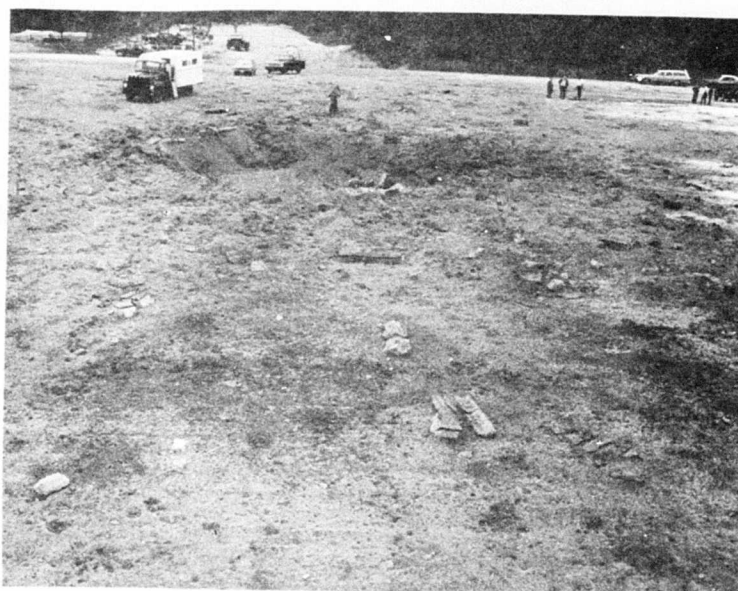
Because of the spread of the ejecta, the ejecta judged as suitable for backfilling by the BDR team was less than the crater volume. Figure 8 shows the ejecta spread in Test 1-2, which was similar to Test 1-1. Extra material was obtained from the shoulder area of the runway and by utilizing coarse aggregate that had been stockpiled for another test. It became evident that the amount of ejecta may not be sufficient to fill the crater

Figure 8. Crater Created by M117 Weapon for Test 1-2, Crater is Similar to Crater Utilized for Test 1-1

if large pavement chunks are discarded. A possible solution is the careful analysis of material on the runway shoulder and inclusion in the base contingency plan of the location of shoulder material suitable for backfilling. Shoulder areas also can be used as stockpile areas for acceptable backfill materials of low value at bases where the ejecta itself may not be suitable. As an example, sand shoulders could serve as stockpiles for locations where a high water table with a highly plastic saturated clay material would preclude using the ejecta as backfill.

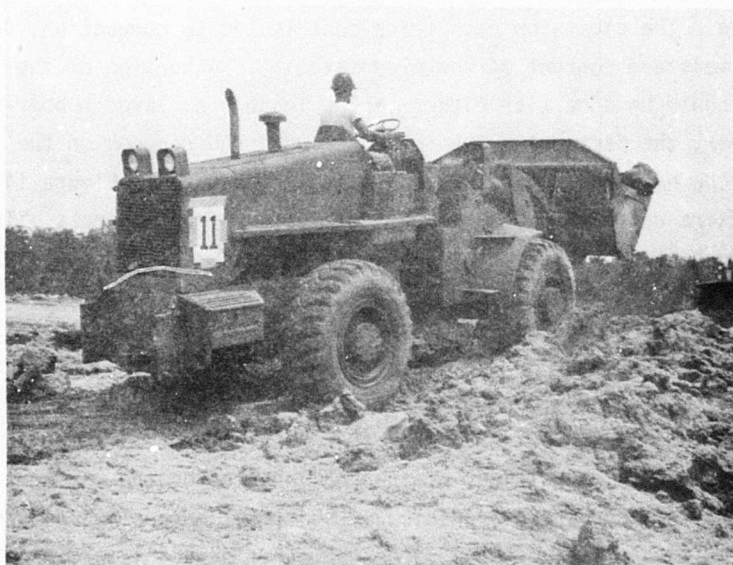
Figure 12. Test 1-1, AC 645 Loader Forced to Lift and Drop Debris into Crater

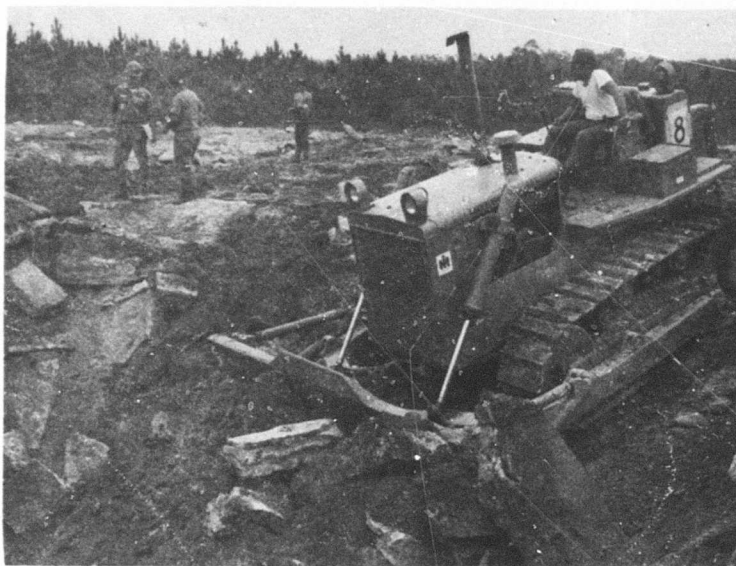
This item proved to be the most versatile and useful piece of equipment in the test. Its capability to push large amounts of debris into the crater and to "walk" into the crater to compact material was excellent (figure 13). However, the large tread size made the actual compactive effort smaller than desirable. The cleats on each track contributed to compaction, due to the near optimum moisture content of the clay material. A portion of the job done by this item could be done with either larger loaders or large rubber-tired dozers; however, the particular type of dozer required depends on the subgrade condition at the base where the BDR capability is required. Figure 14 demonstrates the extra capability of a large dozer versus front loaders. The left side of the crater was worked on by two to three loaders, while only the TD-20 dozer had worked on the right side.

Figure 13. Test 1-1, TD 20 Full Tracked Dozer Pushing Large Debris Directly into Crater

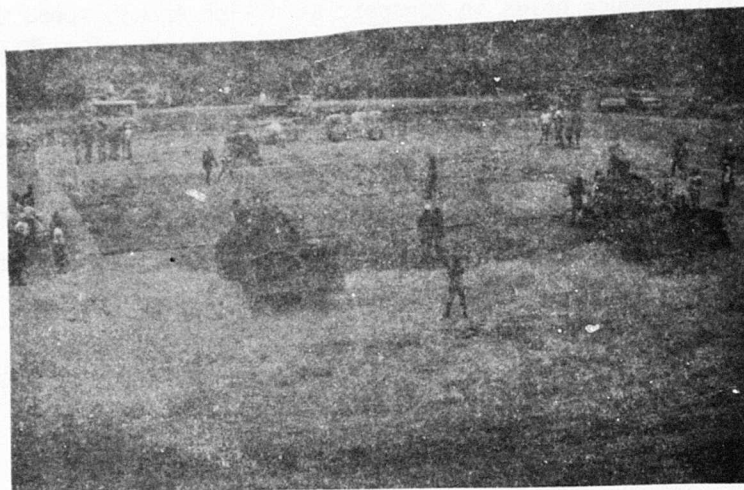
Actual placement of the mat went quite smoothly. The two AC 645 front loaders provided adequate towing power. The move was made by first pulling the mat to a position alongside the repair area (figure 21) and then pulling the mat laterally across the repair (figure 22). Some displacement of the prepared base course did occur and could have caused local depressions in the finished mat surface.

Figure 22. Test 1-1, AM-2 Airfield Patch Being Towed into Position Laterally

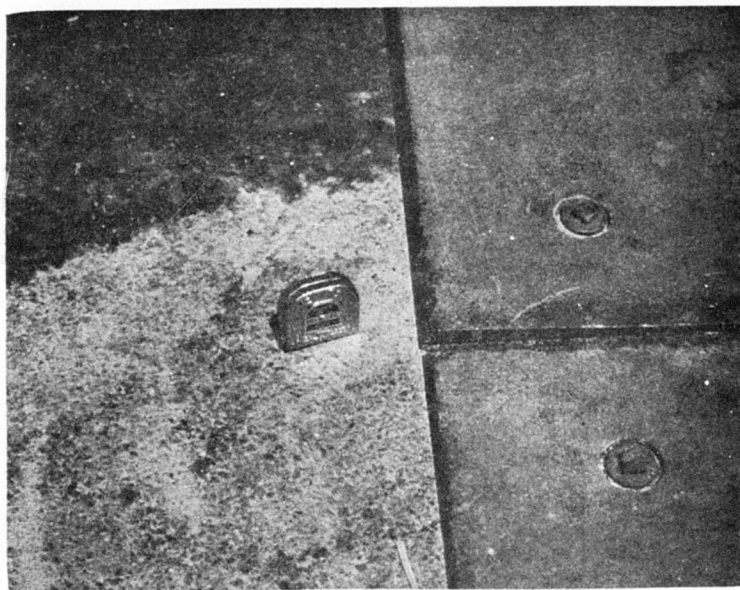
Problems were encountered in the placement of the ramps due to the crown on the pavement section. The ramp was not designed to be able to follow breaks in slope or vertical curves. Figure 23 shows a 1/4-inch height differential between adjoining ramp sections. A redesign of this may be a requirement, although the latest ramp design was not tested.

Figure 23. Test 1-1, Mismatch of AM-2 Airfield Patch Ramp Sections Due to Crown in Runway

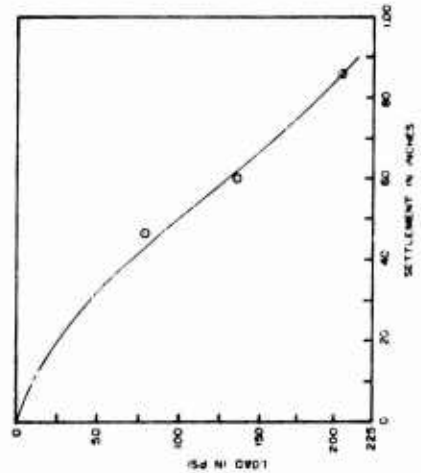
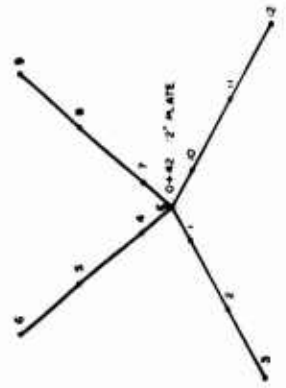
NOTE: WHEN CENTER OF AM-2 IS LOADED, EDGES BREAKS CONTACT WITH BASE COURSE

50,000 pounds on the plate, thus simulating the high tire pressure of the F-4E aircraft and the total gross gear load of the F-111A aircraft. Figure 25D depicts the load-settlement curve, and demonstrates that nearly a 0.1-foot settlement was generated by a 220-PSI, 25,000-pound total, loading. This loading is less than the PSI loading of the F-4E aircraft (265 PSI) and the total one gear loading (47,000) of the F-11A aircraft as shown in reference 20.

(b) Figure 25E shows the deflection basin formed by the loaded plate. As can be seen, the AM-2 mat lifted off the base course at points surrounding the load due to the extreme deflection under the load plate.

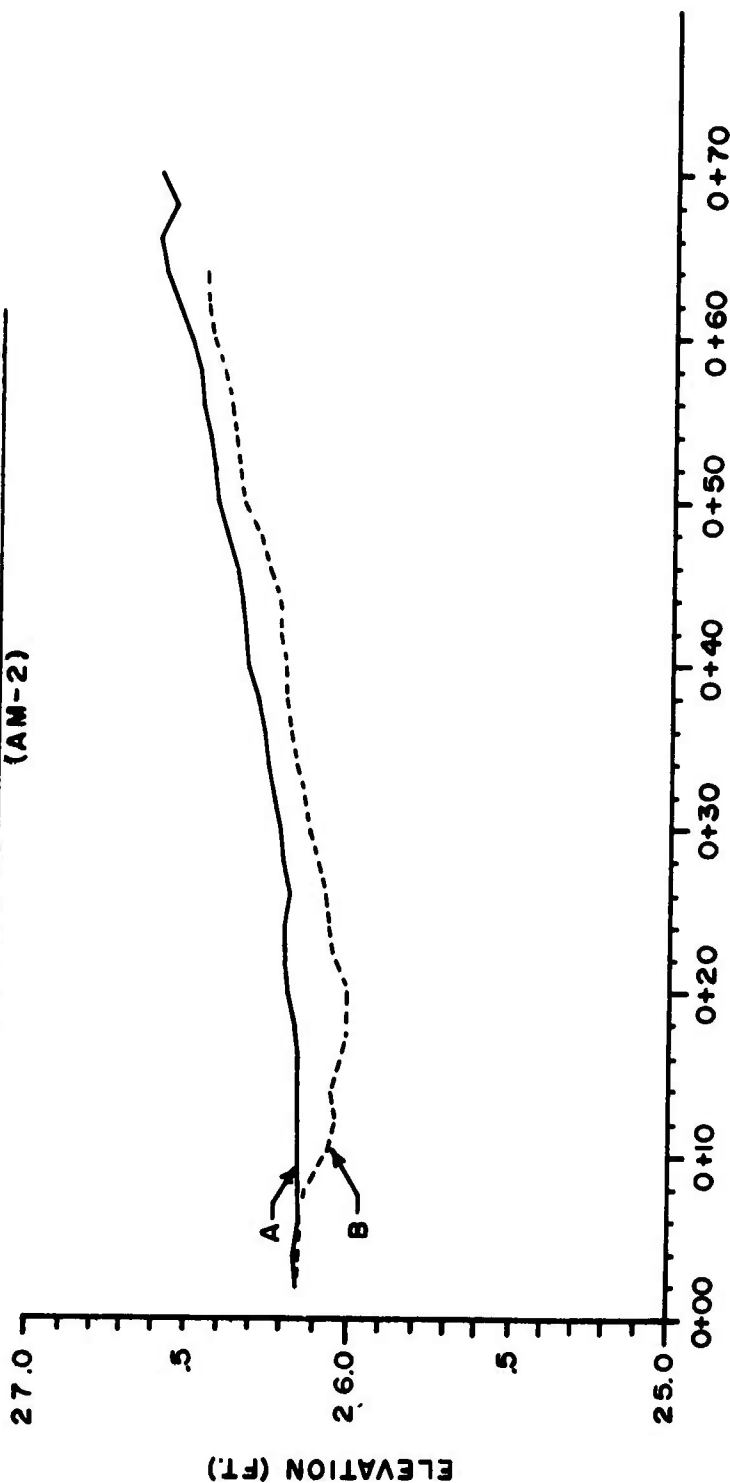
Further testing was done with an F-4 load cart, shown being loaded in figure 28, with a main gear load of 29,000 pounds, exceeding the F-4E aircraft (one gear weight of 27,000 pounds) by 7 percent. Elevations were taken at 2-foot intervals on the mat at three different times as shown in figure 29. These points coincided approximately with the middle of each 2-foot mat section.

Figure 29. Test 1-1, Deflections of AM-2 Airfield Patch Surface
Resulting from F-4 Load Cart Trafficking

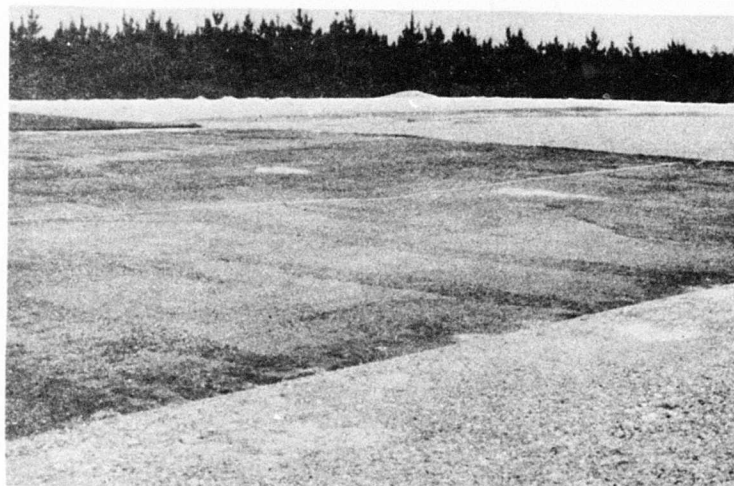
some systems other than AM-2 would initially keep moisture out of the back-fill material, the presence of high water tables could result in this type consolidation.

Figure 38. Test 1-2, Repaired Base Course Deflection Following Heavy Rains during a Three Day Period

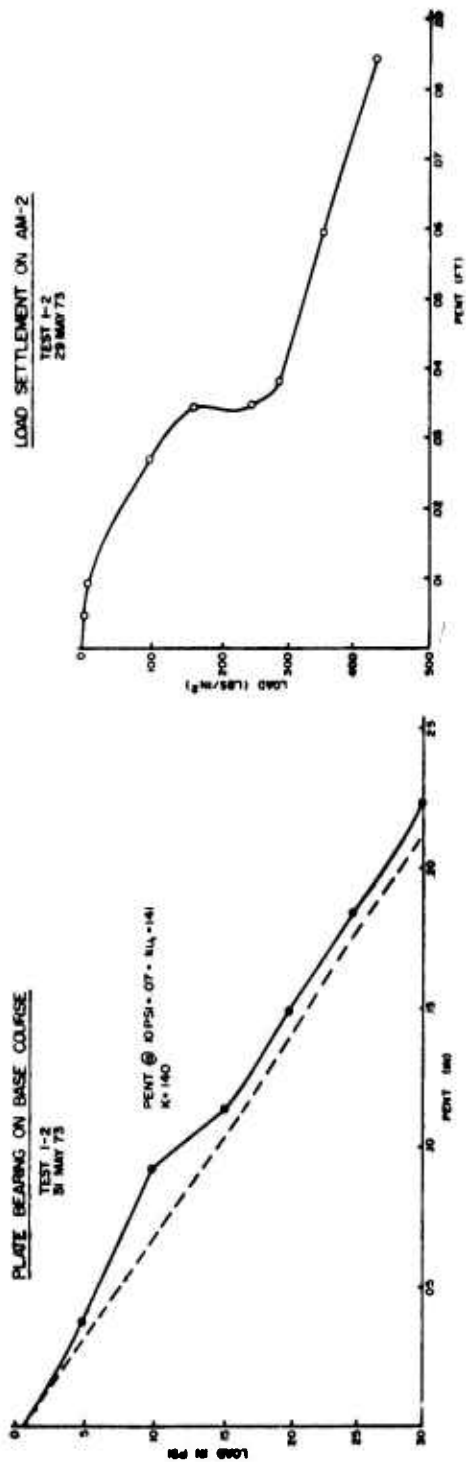
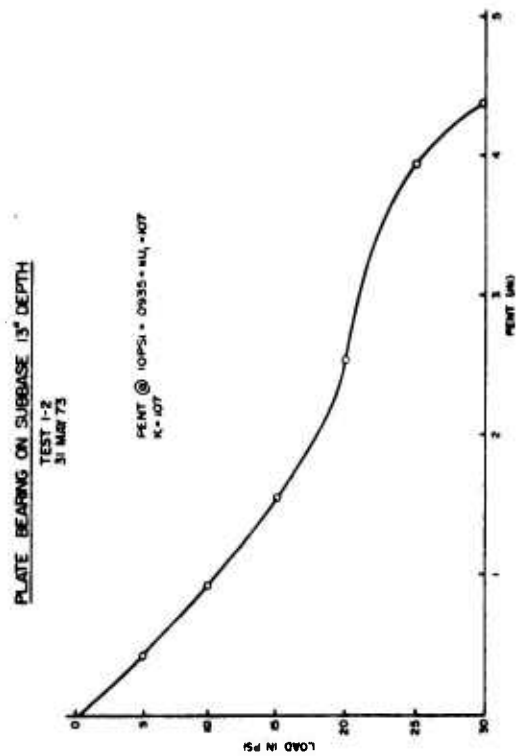
(1) Load testing of the crater was begun after the base course was regraded and compacted to give an acceptable repair grade. Figure 39 shows the surface penetration resulting from loadings on the AM-2 matting. Load penetration relations for the subbase and compacted debris are also shown. In the latter cases, a 30-inch diameter plate for standardized testing was utilized. Loading on the AM-2 was accomplished with a 12-inch diameter plate to simulate an F-4C wheel load.

Figure 39. Test 1-2, Plate Loading Test Penetration Curve

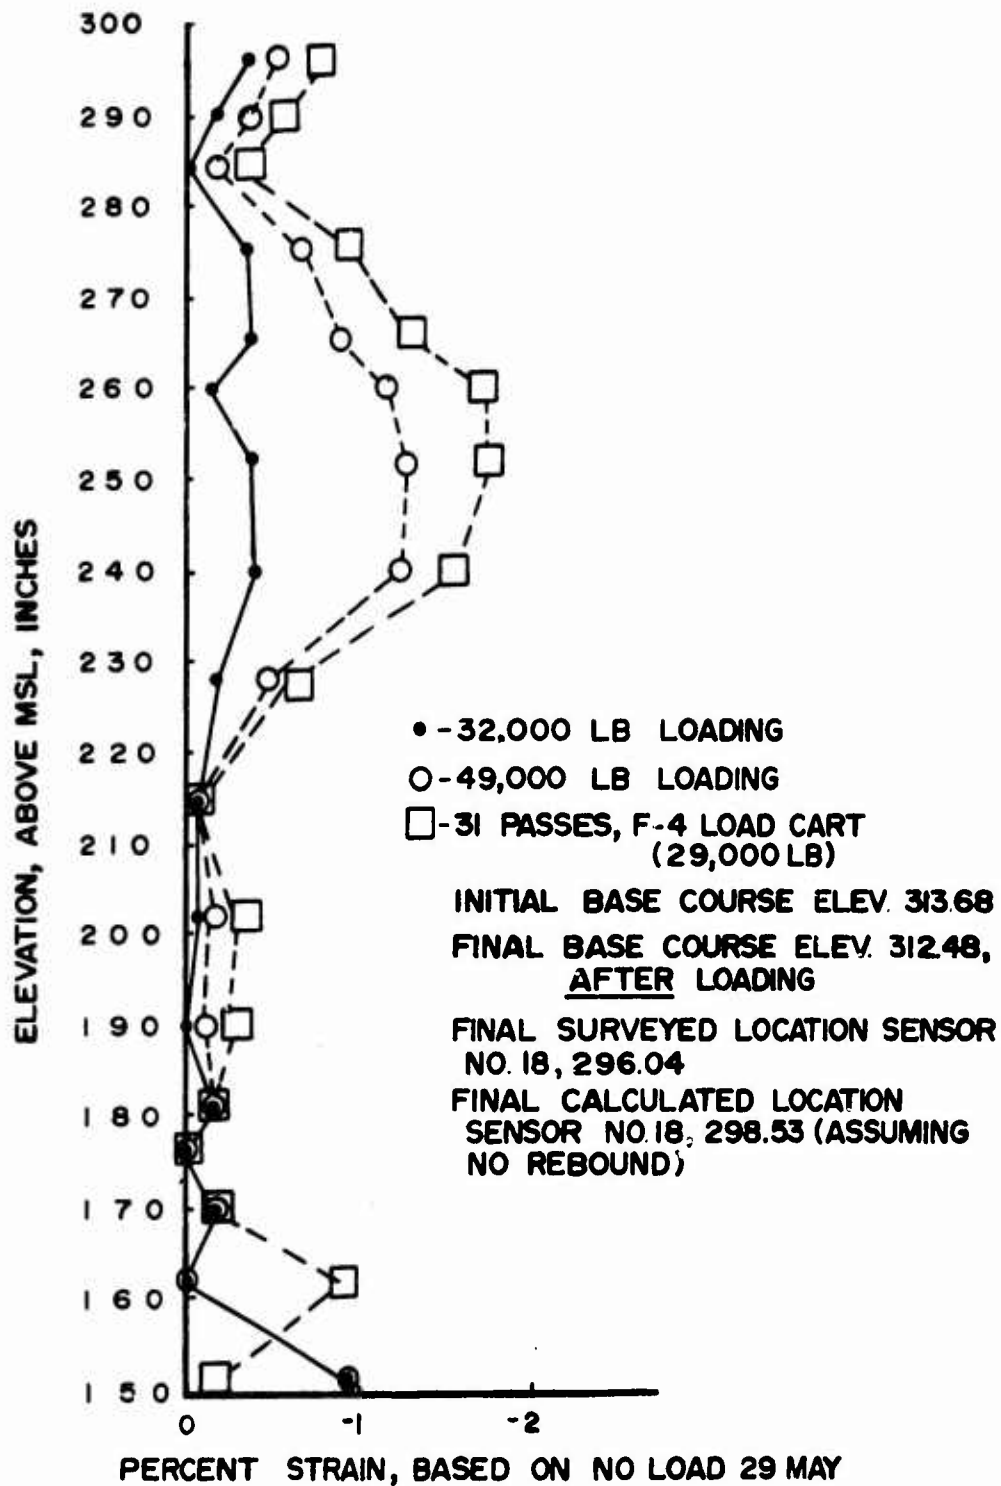
Figure 43, Test 1-2, Loading Strains

The most valuable information gained from Test 1-2 is shown in figure 43. The distribution of the load through the base course and back-fill reached a point where rapid consolidation due to short term loading no longer constituted a BDR problem. In particular, it is seen that the influence of loading is minimal below a depth of about 7 feet. If a homogeneous condition could be assumed to exist following the saturation induced consolidation, the conclusion is that maximum consolidation for this 93-2 type repair occurs between 2.5 and 5 feet beneath the surface of the base course material. This leads to the conclusion that one can ignore extensive time consuming compaction on material deeper than 5 to 6 feet below the surface. Maximum compactive effort should be given to material less than 6 feet deep.

The questionable location of sensor 1 indicated that the bottom of the crater could create large surface deflection problems even if the crater were backfilled with a material of known and excellent engineering properties. In Test 1-2, the fallback material and the true crater floor were both excavated. Still, based on the location discrepancies of sensor 18, it can be assumed that sensor 1 moved downward. This occurred during the long-term settlement. It indicates that without excavating large amounts of fallback and sheared and crushed crater floor material, similar to that shown being tested (figure 44), excessive long-term settlements will occur regardless of how well the crater itself is backfilled. This leads to the conclusion that long-term settlements cannot be eliminated and that the repair technique adopted must be able to cope with them. This automatically eliminates a rigid crater repair surfacing. The British have already faced this problem, since a key portion of their repair techniques involves excavation of unsuitable materials from the crater (ref. 23).

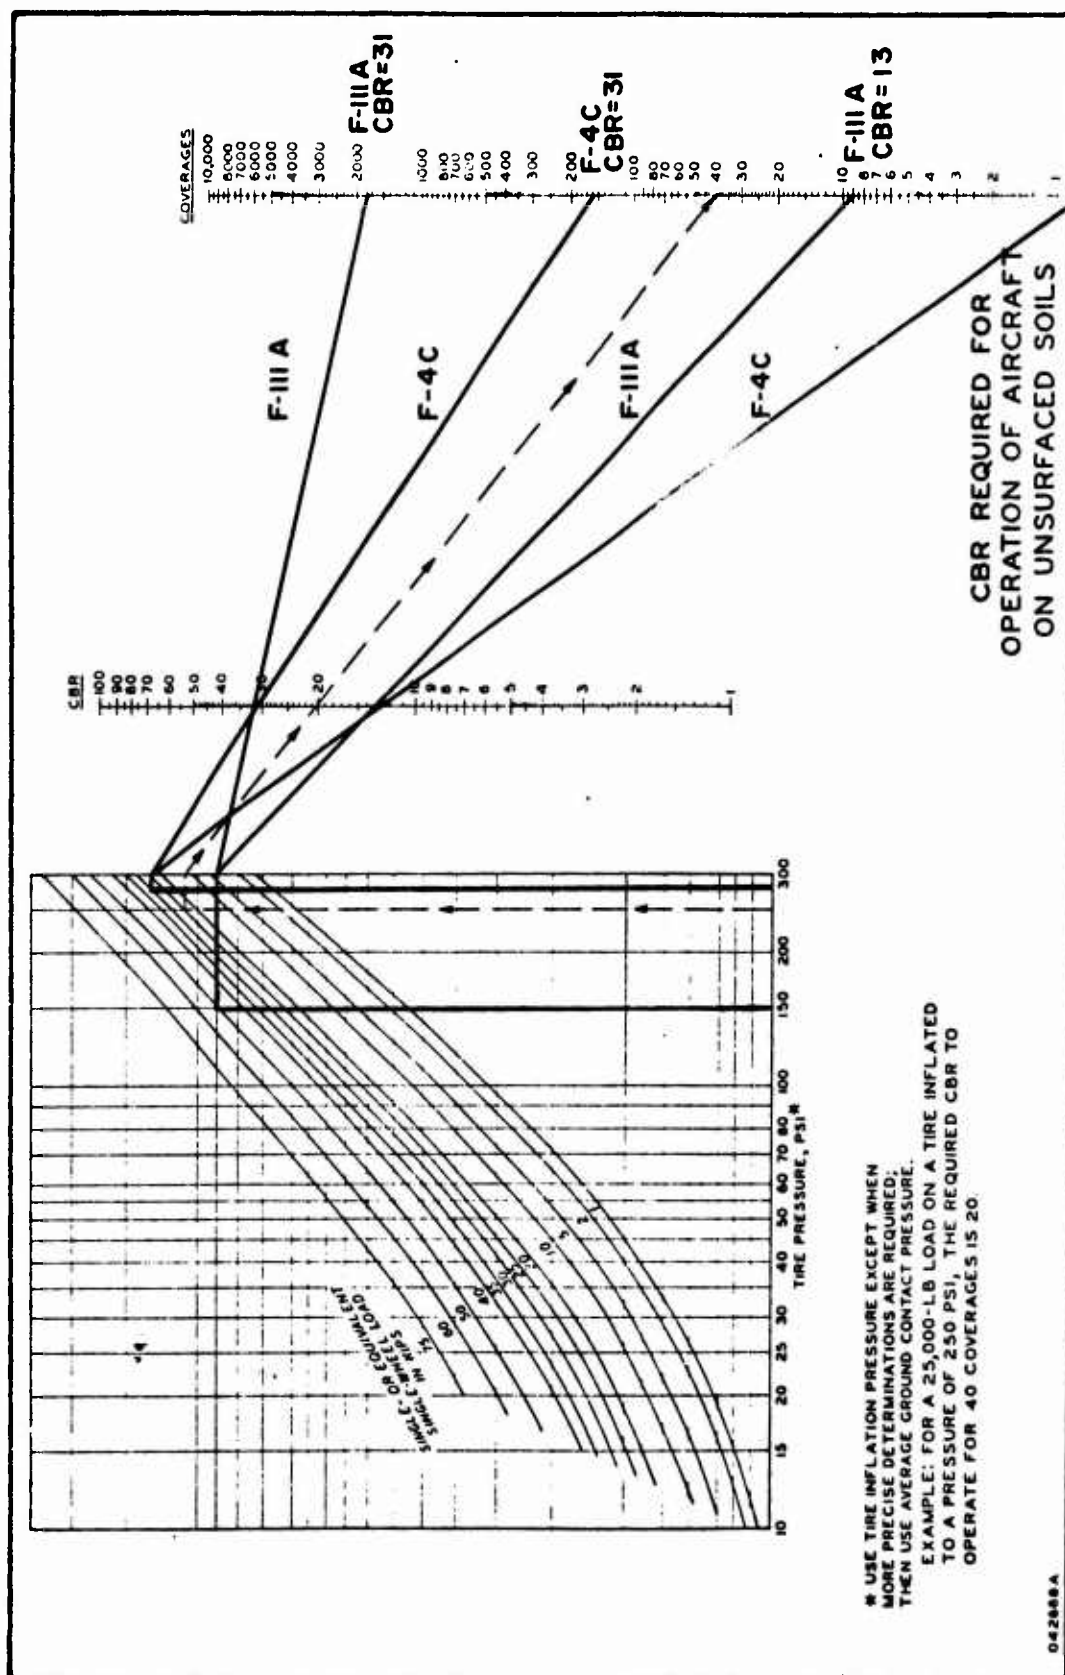
Figure 45. Test 1-2, CBR Requirements for Operation of Aircraft on Unsurfaced Repairs, after Reference 2.

The second observation is based on reference 26. The CBR rating of the compacted debris was 13. Figure 45 indicates that the debris subgrade was incapable of being utilized to launch F-4C type aircraft. Had the debris been brought up to the surface level of the runway, figure 45 indicates that it could have been used for up to 9 coverages by F-111A type aircraft without benefit of a capping material. The base course, with a CBR of 31 would have been capable of sustaining 160 coverages of F-4C type aircraft or 1,800 coverages by F-111A type aircraft. Load cart testing of the base course without the AM-2 surfacing was not attempted. Reference 2 indicates that a lengthy method of repair not utilizing AM-2 or other surfacing is acceptable. The above indicates that under the proper conditions consideration can be given to deletion of the AM-2 matting if the timely completion of aircraft mission requirements is in question.

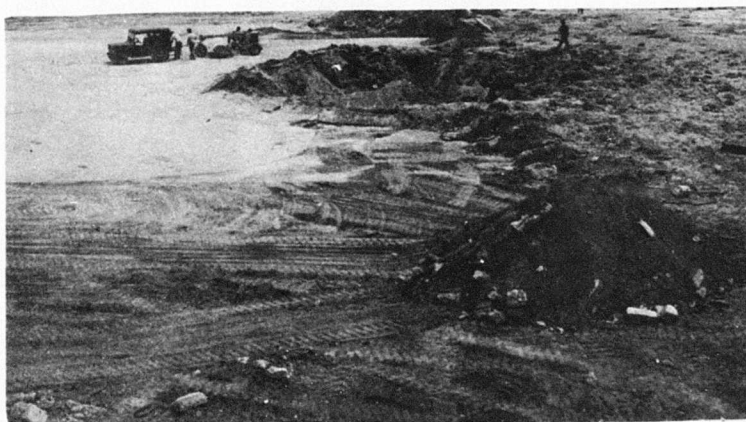
During Test 1-1 it was noted that a primary cause of the excess repair time was the slow removal of heaved pavement. As was discussed earlier, it was noted that the equipment currently in the AFM 93-2 BDR package did not have enough power and/or weight to push the debris directly into the crater and therefore left a lip of debris at the crater edge which hindered progress and caused extra movements of equipment. Figures 46 A, B, and C display the upheaval following removal of fall back and ejecta. In figures 46A and 46C, stockpiled debris to be used in the backfill operation can be seen. Figure 46C shows the break point between the dramatically upheaved, but easily removed, pavement on the crater lip and the more subtly upheaved pavement that can extend 10 to 15 feet beyond the breakpoint.

Figure 46A. Test 1-2, Upheaved Pavement Cleared of Debris on the Left

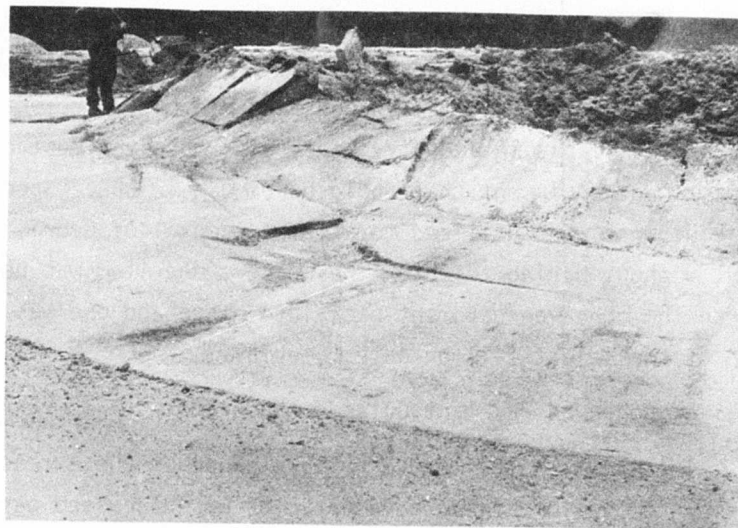
Figure 46B. Test 1-2, Close up of Upheaval

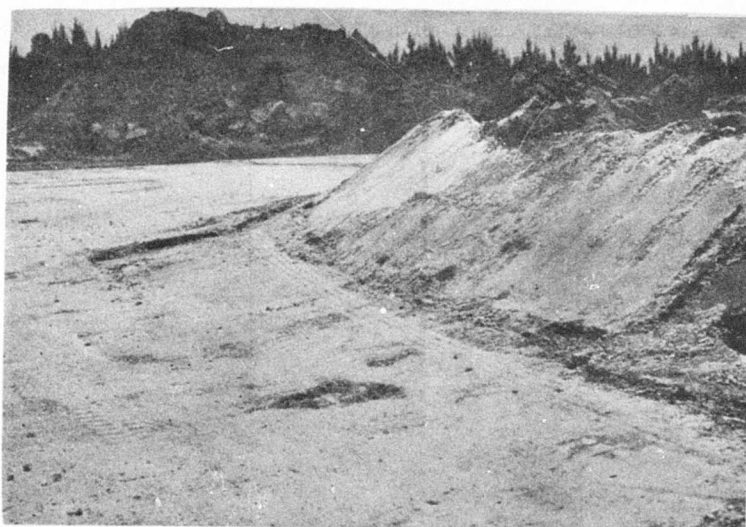
Figure 46C. Test 1-2, Close up of Two Distinct Breaks in Slope, Showing the More Difficult to Identify and Remove Upheaval to the Left

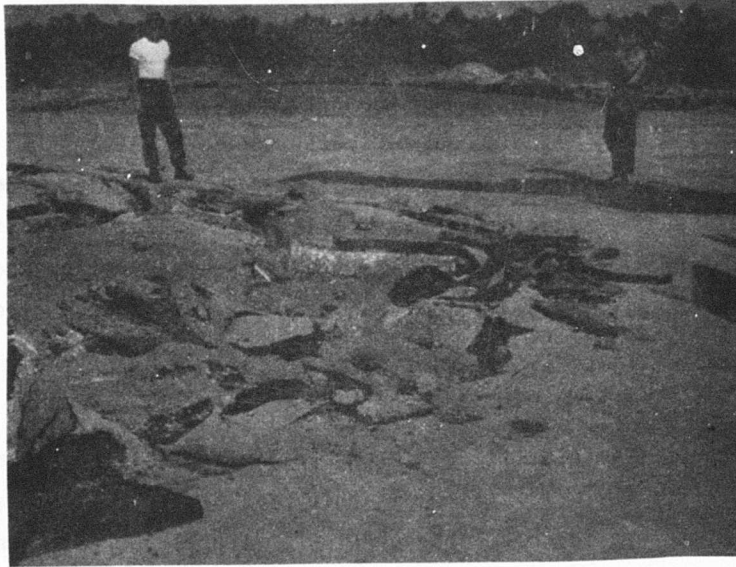
The unit in operation is shown in figure 48. The backhoe proved to be inadequate for this task and could only pull apart small pieces of concrete. It disturbed the base course below the runway, creating additional work for the repair crew (figure 49). While this size backhoe was inadequate, the British use large-wheeled backhoes in their BDR package (reference 23). Tests on this equipment were terminated due to its inadequate size.

Figure 49. Test 1-2, Base Course Disturbed by
AC 645 Backhoe Attachment

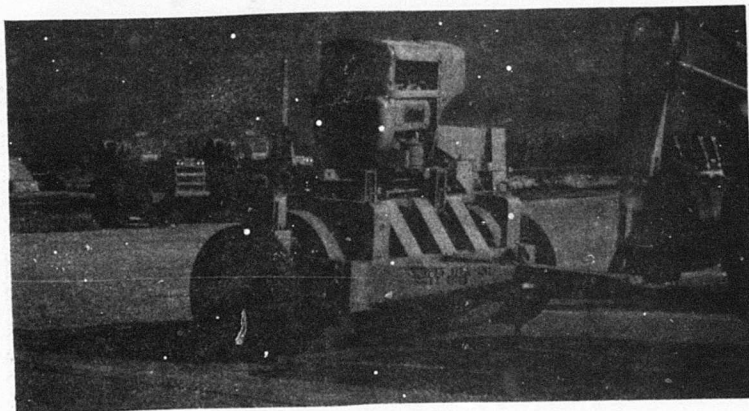
The final equipment test involved a rotary-drum vibrating compactor (figure 55). This was used to obtain maximum density of the select fill material. In addition, the other important ingredient in compaction, moisture, was liberally added. The overall compaction yielded a CBR of 31. Although a CBR was not taken in Test 1-1, it is estimated, based on the deflection of the AM-2 under load cart passages and the plate loading, that it was between 10 and 15. The excellent compaction is shown in table 11. This amounts to 112 percent of the optimum density and 104 percent of density as constructed. Both the compactor and a method of adding water are absolute requirements for successful use of the current BDR method.

Figure 55. Test 1-2, Vibratory Drum Compactor Used
for Base Course Compaction

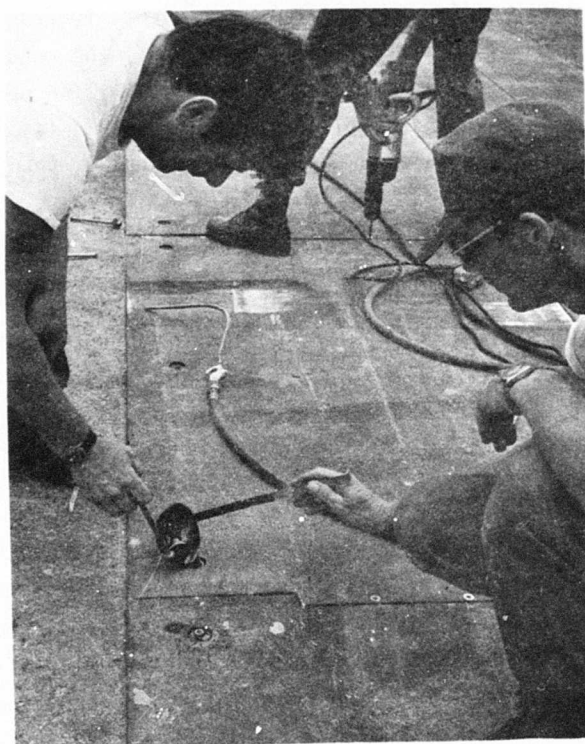
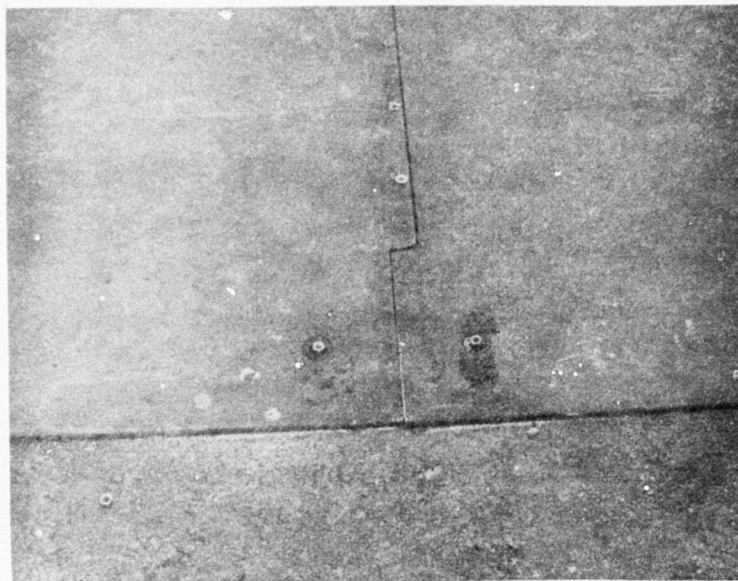
c. The problem of seating the bolts in the hole is more difficult. Several types of expansion bolts were tried, however, a new type of hardware will have to be sought out or designed for this application, and must be matched to the bit used in the rotary hammer. A suitable interim system was devised using bolts anchored head down in a lead-sulphur compound (figures 56A, B, and C). This worked well with the entire job using this method requiring only 19 minutes. An attempt was made to remove the bolts the following day with a grader blade. The bolts bent, but could not be removed (figure 57). However, the electrical equipment required to heat the lead-sulphur must be started in advance. In addition, use of the electrical

Figure 56A. Test 1-2, Molten Lead-Sulphur Ramp Attachment Method of Pouring Lead-Sulphur Compound into Drilled Hole. Bolts and Device Used to Clean Hole are Visible in the Background

Figure 56B. Test 1-2, Molten Lead-Sulphur Ramp Attachment Method with Anchor Bolt in Place

d. The development of a suitable expansion bolt for use in asphalt and concrete should be pursued to eliminate added items of equipment required for the lead-sulphur method. Further work on defining the shear and tension forces which the anchoring system must resist should be done before this development is undertaken.

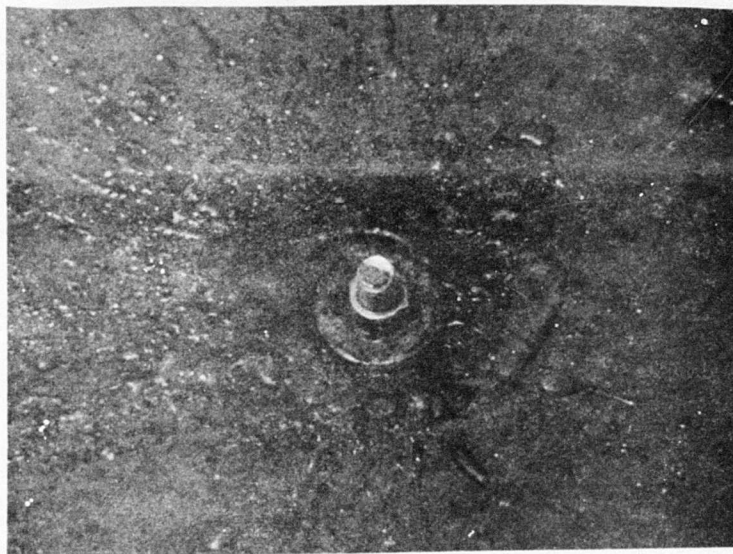
melting pots and the laddling of hot lead-sulphur is somewhat cumbersome. Some method of removing the excess bolt head extension must be developed to insure no damage to aircraft tires is possible.

Figure 56C. Test 1-2, Molten Lead-Sulphur Ramp Attachment Method With Close up of Bolt in Place, Showing Requirement for Grinding

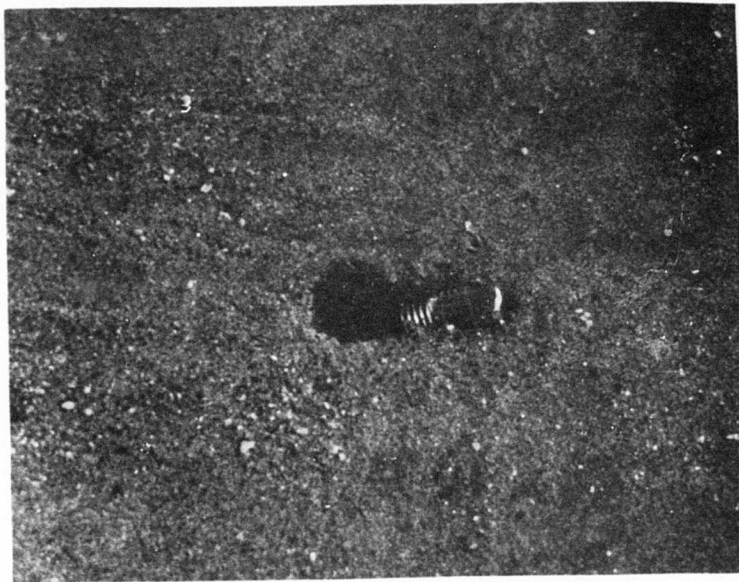
a. A further portion of Test 1-2 was the testing of a new method of attaching the AM-2 matting to the surface. Two items had been shown to be inadequate in the system proposed by AFM 93-2. First, the rotary electric drills specified in AFM 93-2 were inadequate to drill the required number of holes. Test 1-1 was in fact terminated before the drilling procedure was completed. Second, the expansion shields placed in the drilled holes were not capable of withstanding either shearing or tension in asphalt. These would not only fail to restrain the matting, but, once loose could inflict damage to aircraft engines.

Figure 57. Anchor Bolt after Attempts to Remove with Motorized Grader

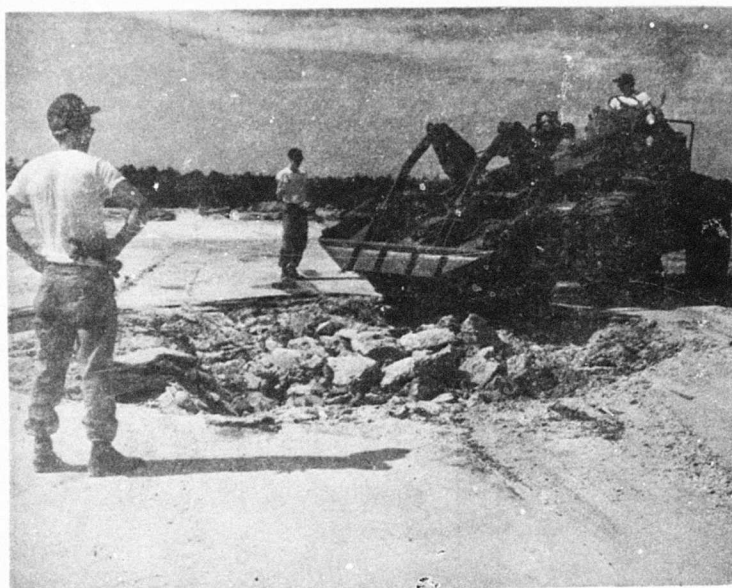
noteworthy. Total equipment usage time was 2 hours and 52 minutes for the AC 645's and 1 hour and 21 minutes for the grader. The total repair time was 2 hours and 30 minutes. This is not a representative minimum time, since the equipment operators were told that a proper repair with proper use of equipment was the objective, not minimum time. No particular advantage was gained by utilizing two AC 645's as opposed to one. The total time during which both 645's were working was only 51 minutes. A portion of this time was spent with mechanical problems on the reverse gear of one of the loaders. The use time of the AC 645's was also increased by the inadvertent over-filling of the crater with debris (figure 66). This required pushing material out of repair area. In addition, it created the presence of large pieces of concrete debris near the subgrade surface. This resulted in difficulties in leveling and compacting the subgrade.

Figure 66. Test 1-4 NE, Crater Overfilled with Debris Requiring Removal

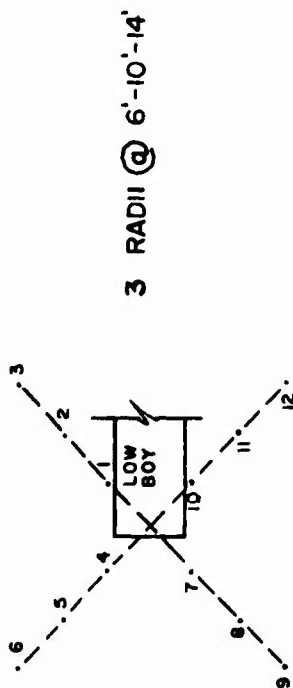
Figure 67. Deflection Basin Study, AM-2 Load Test, Crater 1-4 NE

Loading tests performed on the crater (figure 67) showed marginal compaction. The use of the large concrete debris in a crater repair of this size probably aids in the load carrying capability, but hindered the compaction process. The base course had a k value of only 168 pci, with a CBR of only 11.5. The compacted subgrade could not be plate loaded due to the concrete chunks present. The dry sandy nature of the debris and the dry state of the base course was responsible for a lower than normal average CBR reading of nine.

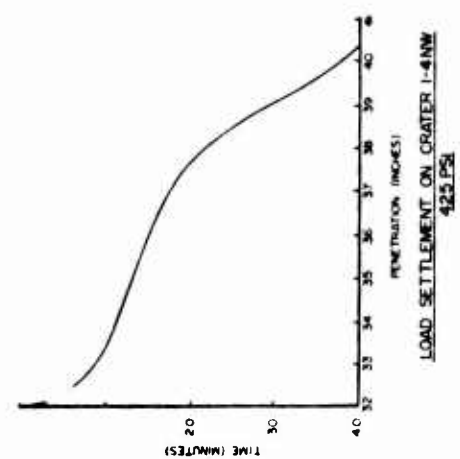
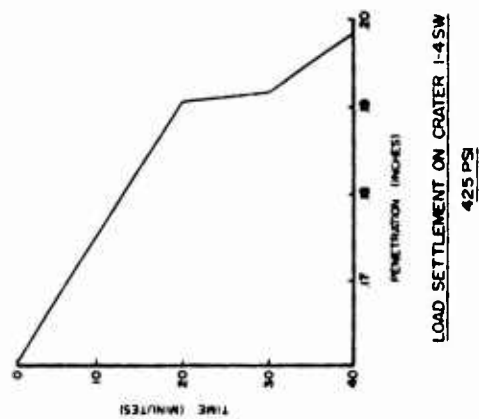
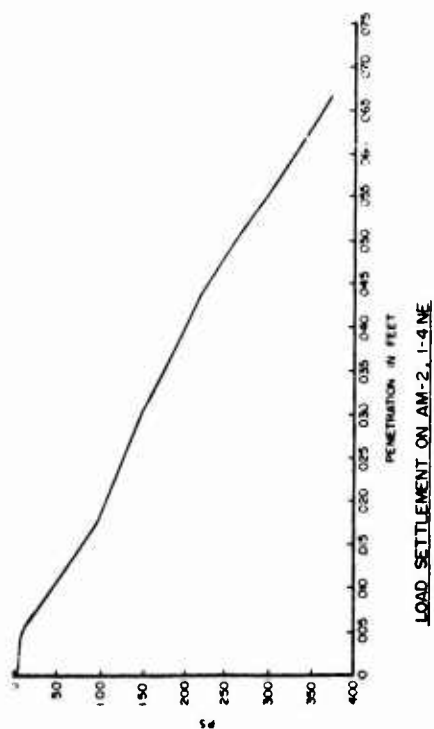
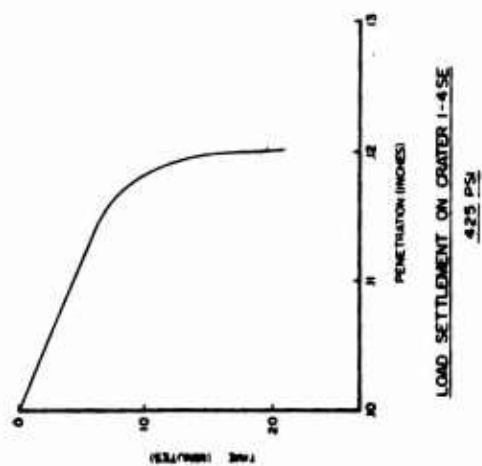
Figure 71. Test 1-4, Loading Curves

The section was load tested after completion. The equipment difficulties had resulted in a layered pavement system over the center of the repair. The actual loading point was over the originally prepared subgrade rather than the center of the repaired crater, as would have been desirable. The load-deflection curve is shown in figure 71.

(2) The debris subgrade was covered with a 1-foot thick course of uniformly graded aggregate in the 0.5 to 0.75-inch size range. Reg-set cement slurry was infiltrated into this to form a type of concrete. This reg-set operation is covered in section VIII. Loading of the surface was successful, with figure 71 showing the load-penetration relationship.

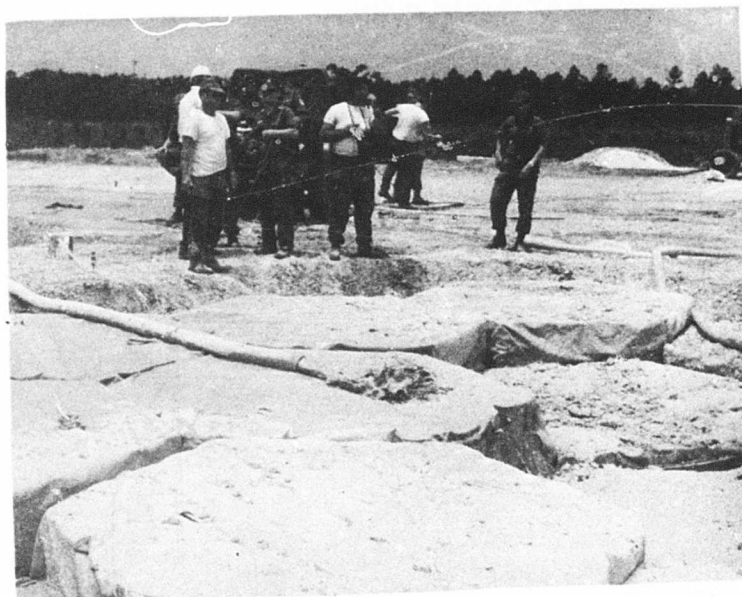
Figure 86. Test 2-1, Extreme Unevenness, Top or Third Layer

(7) One major problem developed in the placing of the modules. Several of the modules in layer 2 could not be placed exactly level. As a result, the top of layer 3 was extremely uneven, with the difference (figure 86) being as great as 1 foot. While this wasn't critical for load carrying capability, it did create a requirement for approximately 30 percent more reg-set in the crater cap.

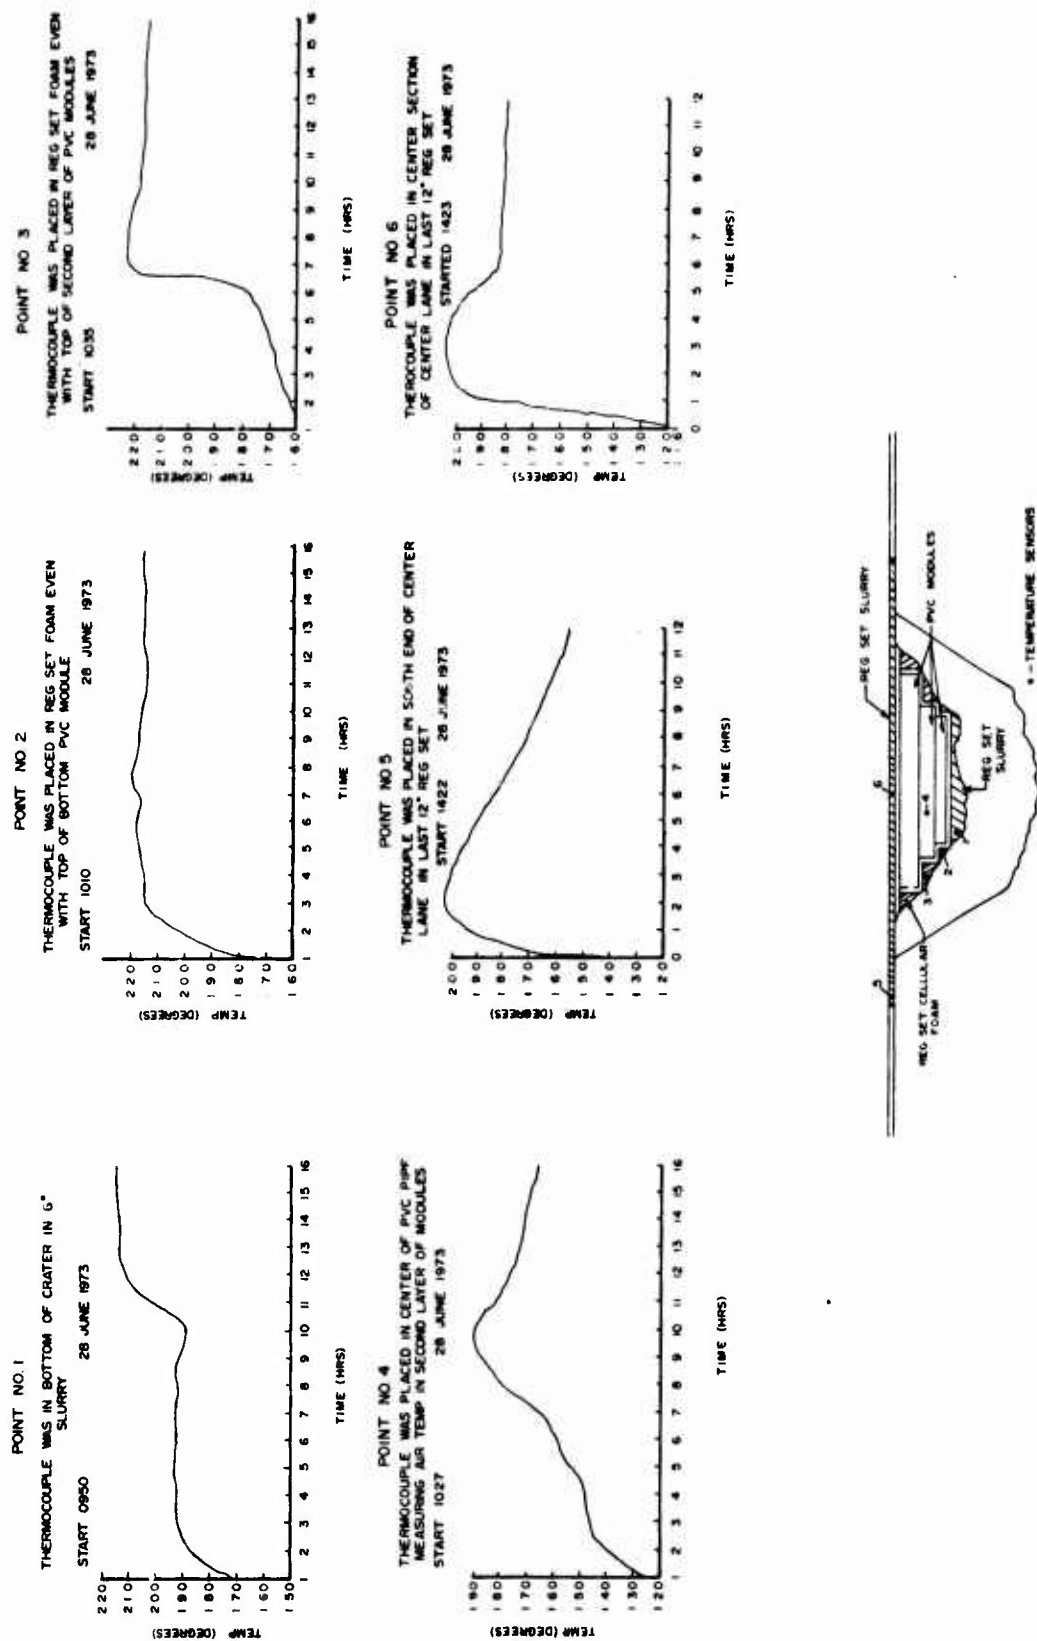
(1) During the test, temperature sensitive thermocouples were implanted as shown in figure 87, a continual record of the heat generated by the curing reg-set.

Figure 87. Test 2-1, Continuous Temperature Recording of Emplanted Thermocouples

The importance of the dramatic temperature rises became clear when the loading of the test section was attempted. As in the other tests in this series, a load of 50,000 placed on a 12-inch diameter plate was to be used along with a load cart carrying 29,000 pounds on an F-4 wheel. Problems began as soon as the loaded lowboy trailer was backed onto the repair. Even though 2-by-8-foot planks of AM-2 matting were utilized to prevent concentrated loading prior to testing (figure 88), failure began almost instantly. Large circumferential cracks (figure 88) occurred along with the release of steam and water vapor from the interior of the modules. The plate load tests were discontinued after a sudden punching failure of the reg-set cap at 30,000 pounds (figures 89 and 90). Although thickness of the cap at the point of failure is uncertain, it was in excess of 12-inches, possibly as much as 20-inches thick. The failure was similar to that experienced in Test 1-4 NW, suggesting a failure of the supporting backfill material. Following this failure, one large slab 10-feet in width cracked and lifted up 3 inches over a 20-foot span along a 2-by-6 inch forming timber, allowing hot gases to escape before dropping back into position. An attempt to use the F-4 load cart failed when the pavement collapsed beneath the load and allowed the aircraft tire to penetrate the pavement, stopping only when the frame of the load cart rested on the pavement (figure 91).

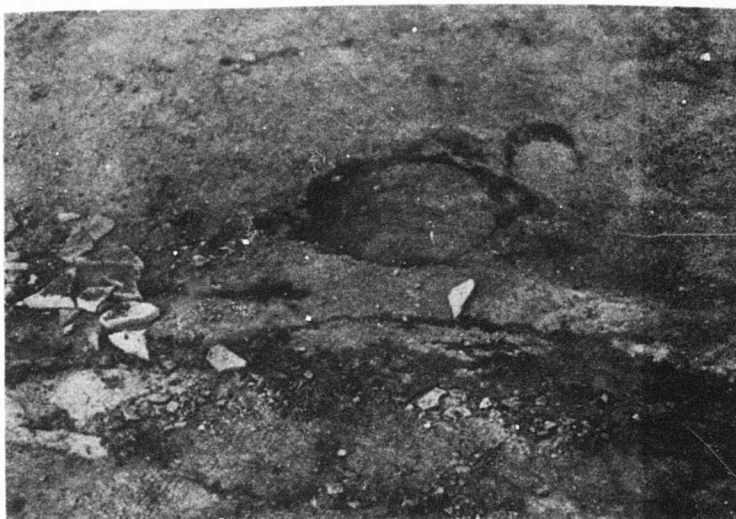
Figure 90. Test 2-1, Punching Failure, Middle, and Concentric Crack, Lower

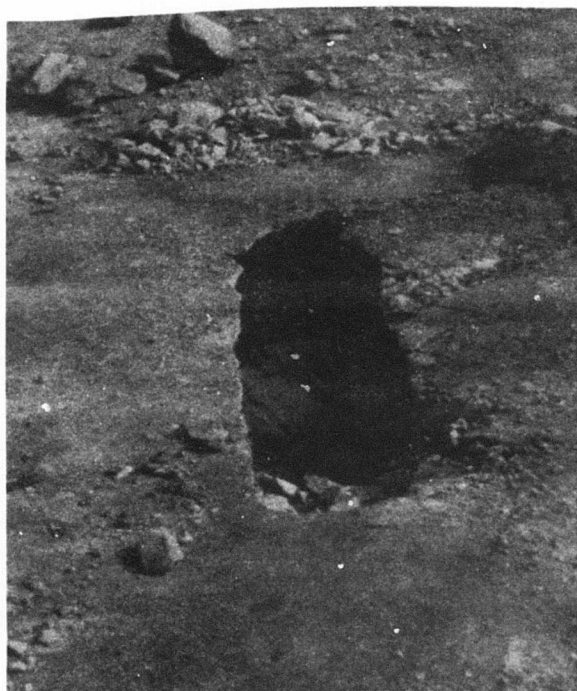
Figure 91. Test 2-1, Punching Failure under Load Cart Wheel

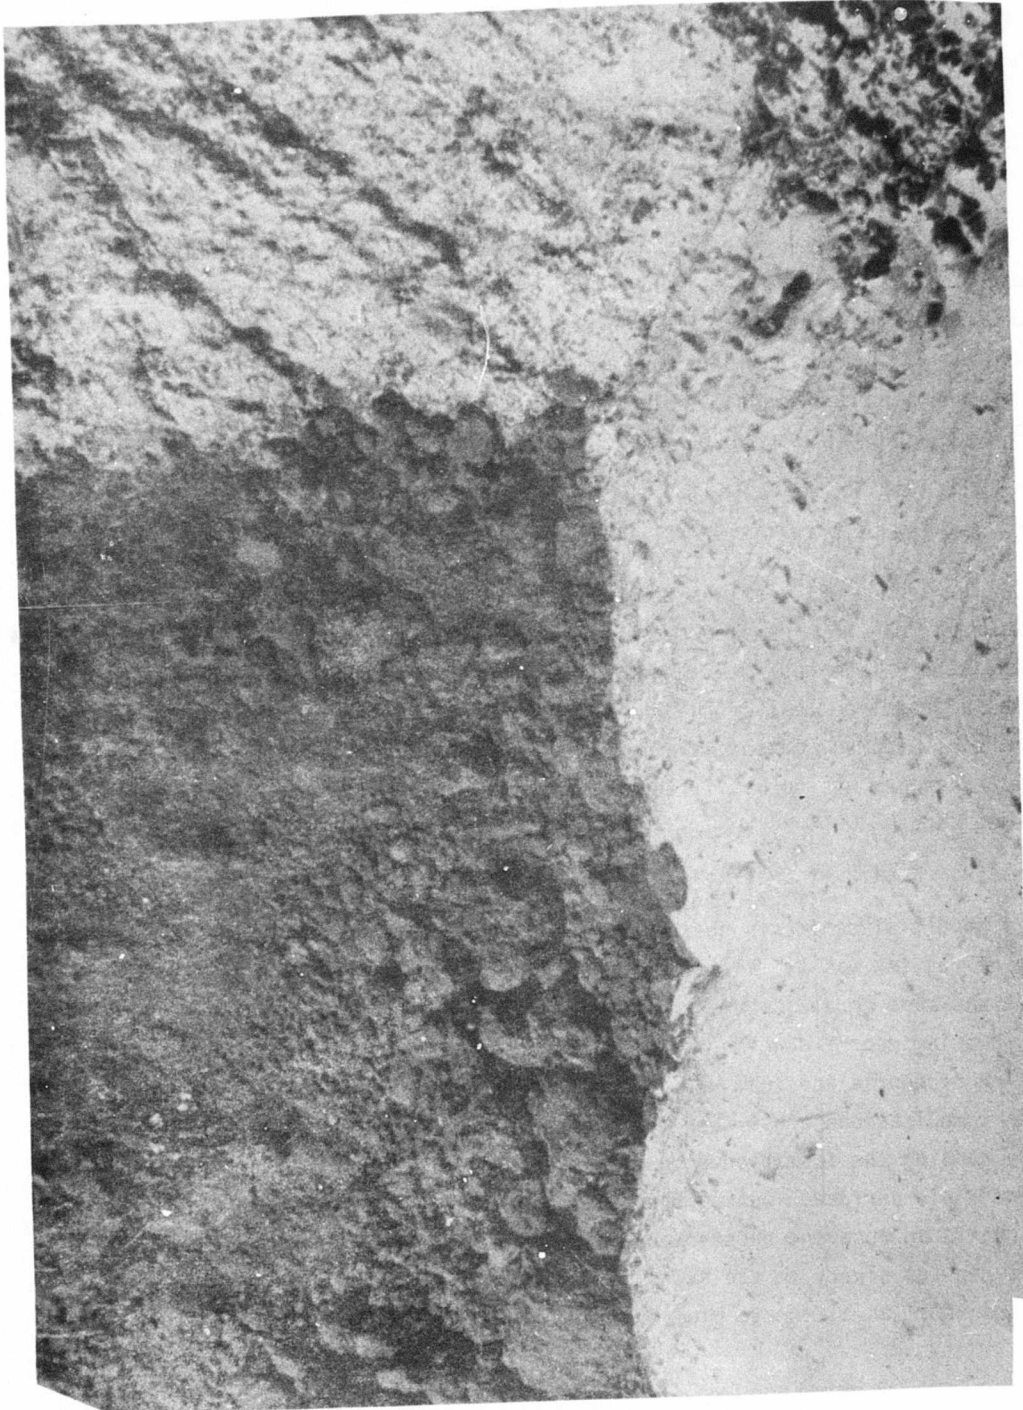
Module placement in the first crater was rapid. In fact, the supply of reg-set was too slow to produce accurate time results. An attempt was made to add debris to the reg-set foam, but the method of merely pushing debris down the side of the crater was inadequate (figure 95). No mixing of debris and foam was accomplished and the attempts were abandoned. Further complications arose when the reg-set placed in the crater cured too rapidly causing the formation of numerous cold joints and a highly irregular and unworkable surface. During the pumping of the cap, a hose connection broke due to an apparent pressure build-up in the system. This breakdown allowed reg-set slurry in the PVC pipe supply system to set up, stopping the operation until an alternate pipe system could be connected (figure 96).

Figure 95. Mixing Problem, Debris with Reg-set Matrix Concept
